MEMORANDUM

Re: TCRA Armored Cap - Response to Request Regarding Dive Team Summary Report for April 3-9, 2016

**San Jacinto Waste Pits
Channelview, TX
April 3 – 9, 2016**

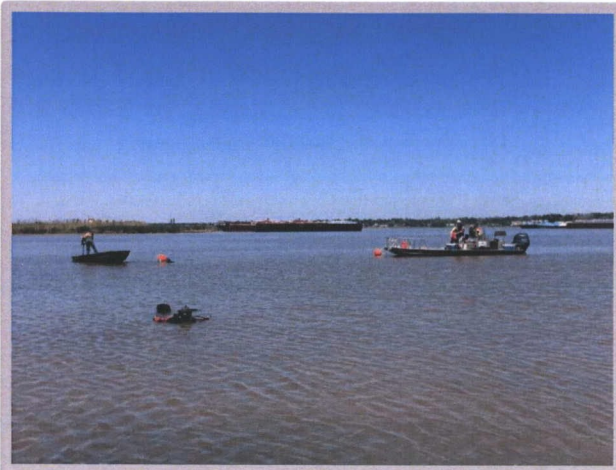
April 9, 2016

Wading activity to determine the presence or absence of rock on the Cap. EPA diver inserted rebar and PVC pipe marking coordinates of AOI-015a and AOI-015b at the outer limits of an area without rock.
